## Commercial Technical Service Department—Service Bulletin

**Issue:** New Vitamix single item number motor replaces 4 different item numbers.

**Subject:** 120 volt Motor ( Drink Machine, 2 Speed, Drink Machine Advance, T&G)

**Replacement Item Number:** 062467 ( Universal Motor Assembly)

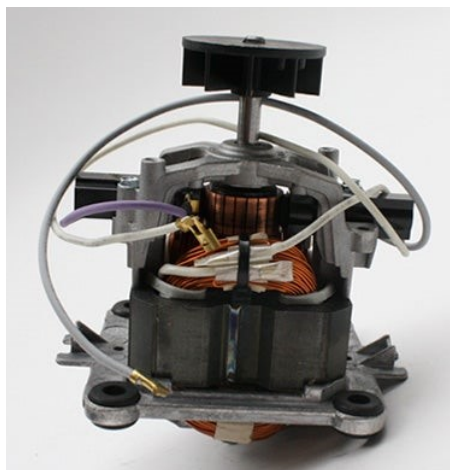
Figure 1

We are replacing the following motor kits 015669,015672,015679,015680 these kits are for the motor shown (see Figure 1) in this bulletin.

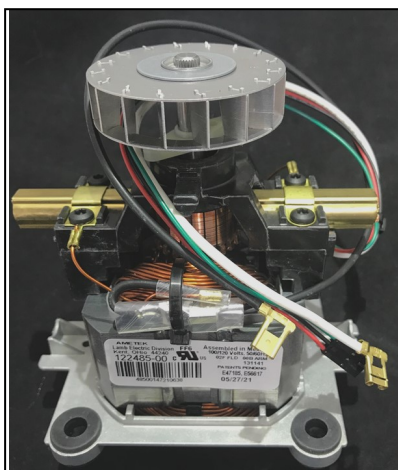
These motor kits will be replaced with Vitamix kit 062467 (see Figure 2.) Figure 2 motor will have the following differences. The new motor will have a metal fan , and brass brush holders,. It will have the thermal cut out (thermocouple) enclosed to prevent damage. The new motor will have white and black motor wires . Please attach the white wire as you did on the current motor, and attach the black wire in the same location you attached the gray wire on the current motor your are removing.

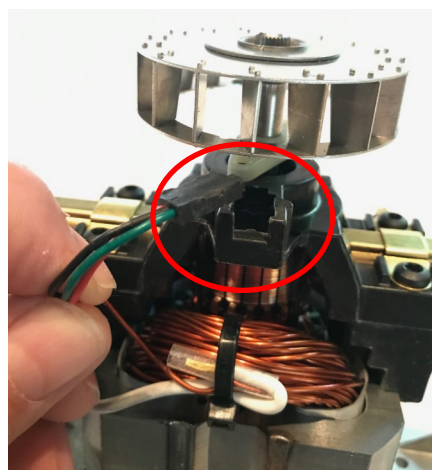
Figure 3

The new motor will have a “Hall effect” speed sensor installed. If you are repairing a blender that does not require this sensor you can easily remove it, by holding the wires, and pulling to physically remove it from its mounting (see Figure 3) If you have blender that requires the Hall effect speed sensor it will plug right in to the control board. We will be updating our exploded view and price list to reflect this change. Please update your records, and web page as necessary.
