## **IMPORTANT PRODUCT SAFETY NOTICE**

This is an important Product Safety Notice to all owners, distributors and service providers of the ProTeam GoFit 3 (model 1076620), GoFit 6 (model 1076630), GoFit 6 PLUS (model 1076650), and GoFit 10 (model 1076640) commercial backpack vacuum cleaners.

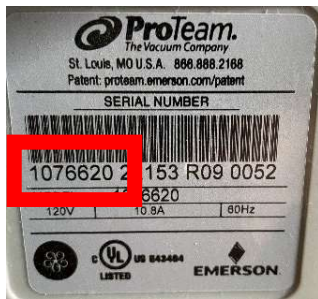
**Figure 1 – Serial Tag**  
*Serial Tag  
Model Number Identification*

2. **Inspect the Switch Box Power Cord for Signs of Wear** –Determine if you have a GoFit 3, GoFit 6, GoFit 6 PLUS or GoFit 10 model by reviewing the serial tag on the back of the product (See Figure 1). If the first seven (7) digits identifying the vacuum model are 1076620, 1076630, 1076640, 1076650 your model is involved with this Notice. Next, look for any signs of gray discoloration on the cord jacket or for exposed internal conductors (See Figure 2). Also, look for signs of intermittent motor operation during use, which may be a signal of conductor wear requiring you to Take Action.

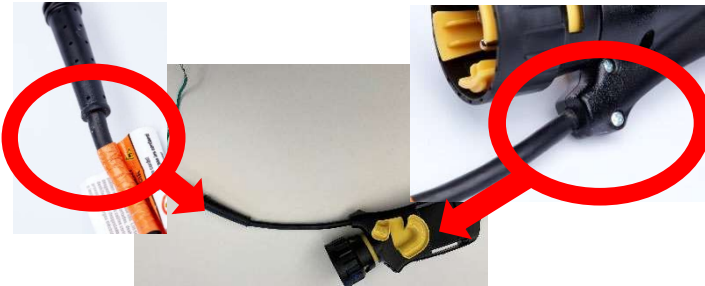
**Figure 2**  
*Locations of wear, such as gray discoloration  
or exposed internal conductors*

**Issue:** ProTeam recently received reports that some users of GoFit 3, GoFit 6, GoFit 6 PLUS, and GoFit 10 commercial backpack vacuum are not properly fastening the waist belt of the body harness and/or not wearing both shoulder straps of the harness, as required, which can cause stress on the switch box power cord and, after several months of use, can cause damage to the internal conductors (Figure 2), potentially resulting in the risk of overheating the switch box power cord and possible injury.

1. **Always Use Both Shoulder Straps and Fasten The Waist Belt While Operating.** Fastening the required waist belt and using both shoulder straps will assure the proper longevity of the switch box power cord and provide the best ergonomic fit for the operator. A link to the ProTeam Owner's Manual, emphasizing the importance of fastening the waist belt and both shoulder straps as well as a cord inspection tips is available at <https://www.proteam.emerson.com/en-us/knowledge-support/video>. The manual also can be directly accessed via the QR code below (See QR1). Additionally, note that wearing the full harness and sweeping the cleaning nozzle as described is proven to allow faster and more effective cleaning while reducing the ergonomic effort of the operator. The ProTeam Video Library online instruction entitled "How to properly wear your GoFit Vacuum" is available on the same website or via QR (See QR2).

3. **Take Action** - If you identify wear or damage to the switch box power cord (Figure 2), immediately stop using the unit and have the damaged switch box power cord replaced before using. You can find local authorized service centers on our website, <https://www.proteam.emerson.com/en-us/knowledge-support/service-centers> . If you cannot find a local center, have questions or need more help, please contact ProTeam Customer Service at [customerservice.proteam@emerson.com](mailto:customerservice.proteam@emerson.com) or at 866-888-2168 for guidance and service options to assist in addressing the issue.
