## Regency 18" x 72" 14-Gauge Stainless Steel Floor Trough with Grate

#600FT1872SS

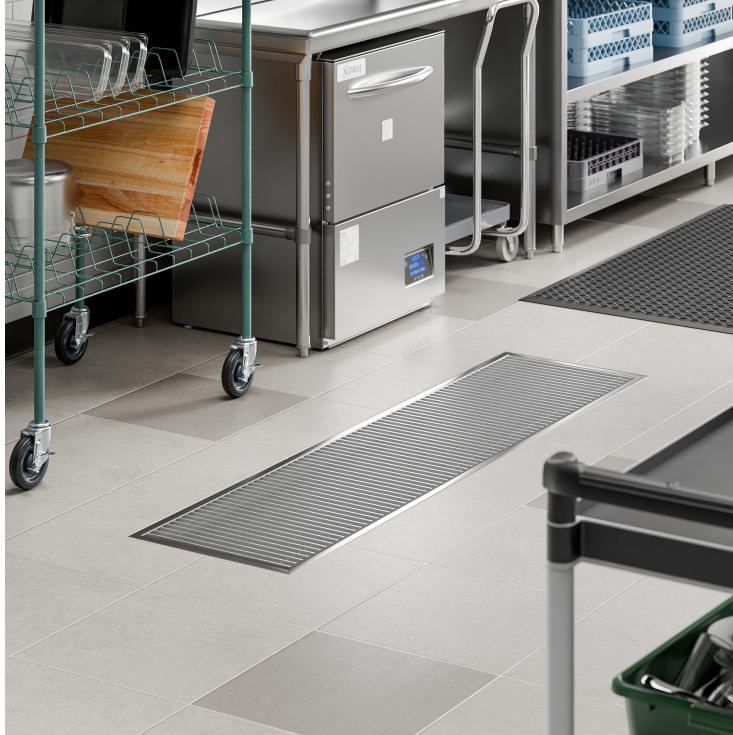
- Features a sturdy 14-gauge, type 304 stainless steel construction
- Comes with a 3" long, 4" diameter plumbing sleeve
- Includes a removable strainer basket for optimal convenience
- Designed with a removable 3/16" x 1" subway-style grating
- Flanges mount directly to the subfloor for added stability

Maintain safe and sanitary floor conditions in your busy back-of-house area with this Regency 18" x 72" 14-gauge stainless steel floor trough with grate. Featuring a durable 14-gauge, type 304 stainless steel construction, this item was built for increased longevity and everyday use. Not only is it great for installation beneath steam equipment in your restaurant's kitchen, allowing for efficient end-of-day draining, but also it can be utilized within any establishment that requires draining of excessive amounts of water. Not to mention, the flanges around the perimeter mount directly to the subfloor to provide added stability.
