# Regency 24" x 96" 14-Gauge Stainless Steel Floor Trough with Grate

#600FT2496SS

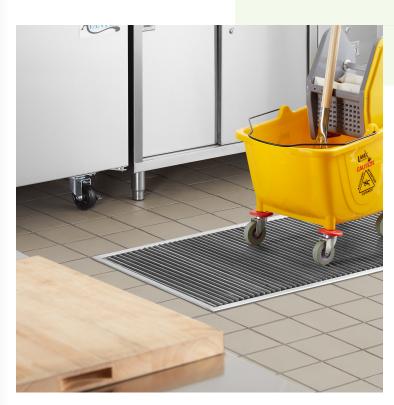
Maintain safe and sanitary floor conditions in your busy back-of-house area with this Regency 24" x 96" 14-gauge stainless steel floor trough with grate. Featuring a durable 14-gauge, type 304 stainless steel construction, this item was built for increased longevity and everyday use. Not only is it great for installation beneath steam equipment in your restaurant's kitchen, allowing for efficient end-of-day draining, but also it can be utilized within any establishment that requires draining of excessive amounts of water. Not to mention, the flanges around the perimeter mount directly to the subfloor to provide added stability.

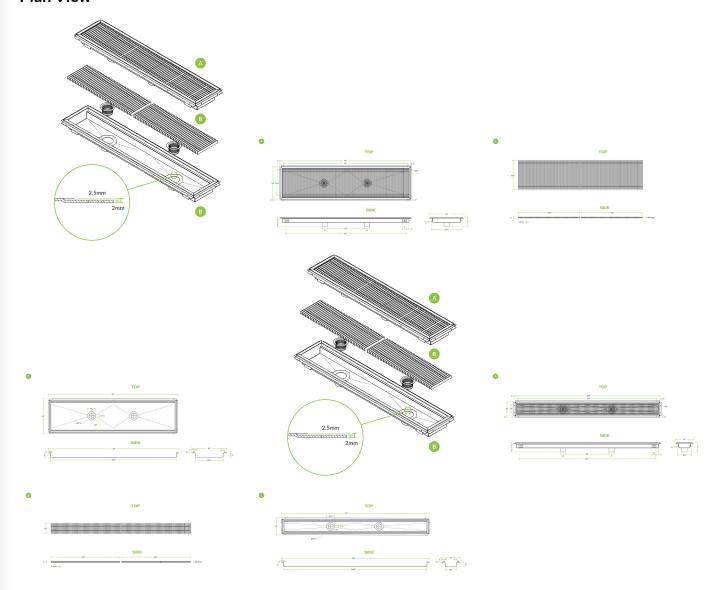
#### **Plan View**

Length	96 Inches	
Width	24 Inches	
Depth	4 Inches	
Features	NSF Listed	
Gauge	14 Gauge	
Material	Stainless Steel	
Stainless Steel Type	Type 304	
Style	Stainless Steel Grate	
Туре	Floor Troughs

- Features a sturdy 14-gauge, type 304 stainless steel construction
- Comes with a 3" long, 4" diameter drain outlet
- Includes a removable strainer basket for optimal convenience
- Designed with a removable 3/16" x 1" subway-style grating
- Flanges mount directly to the subfloor for added stability

This Regency floor trough comes with a removable 3/16" x 1" subway-style grating that boasts an even 9/16" spacing between each bar. This spacing permits fluids to easily flow through, and it blocks potential clogs while enabling equipment and casters to roll over the trough without getting stuck. Plus, this item was constructed with a convenient creased design to ensure proper draining into its 3" long drain outlet, which accommodates waste pipes up to 4" in diameter. It even includes a removable strainer basket for effortless cleaning!
