Regency FTG-18108 18" x 108" 14-Gauge Stainless Steel Floor Trough with Grate

#600FT18108SS

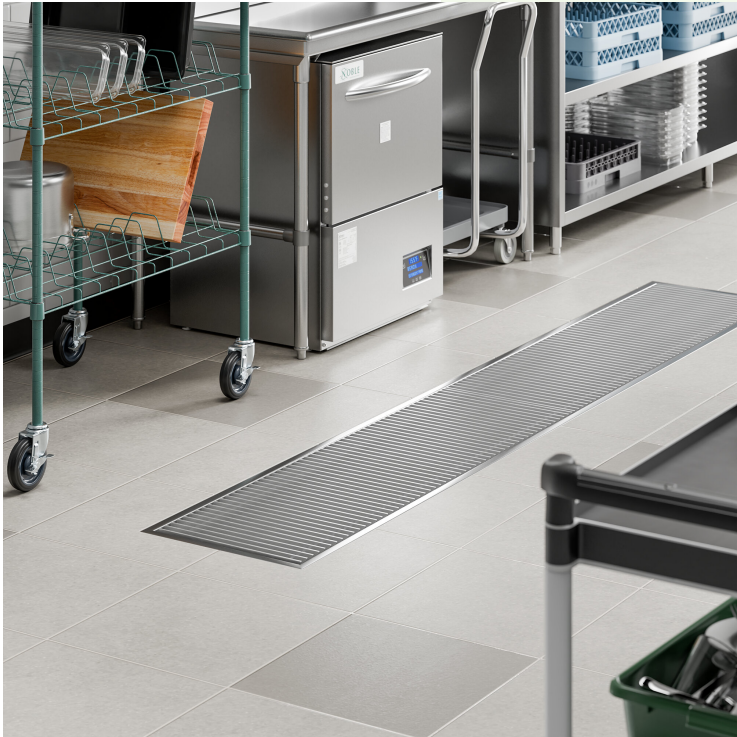
- Features a sturdy 14-gauge, type 304 stainless steel construction
- Comes with a 3" long, 4" diameter plumbing sleeve
- Includes a removable strainer basket for optimal convenience
- Designed with a removable 3/16" x 1" subway-style grating
- Flanges mount directly to the subfloor for added stability
