Regency FTG-24120 24" x 120" 14-Gauge Stainless Steel Floor Trough with Grate

#600FT24120SS

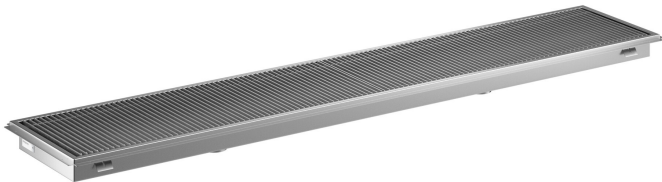
Length	120 Inches
Width	24 Inches
Depth	4 Inches
Features	NSF Certified
Gauge	14 Gauge
Material	Stainless Steel
Stainless Steel Type	Type 304
Style	Stainless Steel Grate
Type	Floor Troughs

- Features a sturdy 14-gauge, type 304 stainless steel construction
- Comes with a 3" long, 4" diameter drain outlet
- Includes a removable strainer basket for optimal convenience
- Designed with a removable 3/16" x 1" subway-style grating
- Flanges mount directly to the subfloor for added stability

This Regency floor trough comes with a removable 3/16" x 1" subway-style grating that boasts an even 9/16" spacing between each bar. This spacing permits fluids to easily flow through, and it blocks potential clogs while enabling equipment and casters to roll over the trough without getting stuck. Plus, this item was constructed with a convenient creased design to ensure proper draining into its 3" long drain outlet, which accommodates waste pipes up to 4" in diameter. It even includes a removable strainer basket for effortless cleaning!
